The May 27, 2014 Inspection of the Kensington Gold Mine

This report covers the May 27, 2014 joint inspection of Kensington Gold Mine. The multidisciplinary inspection team consisted of Brad Orr (District Ranger, Tongass National Forest), David Schmerge (Hydrologist, Tongass Minerals Group), Curtis Caton (Geologist, Tongass Minerals Group) and David Wilfong (Mining Engineer, Alaska Department of Natural Resources (ADNR)). The inspection team was accompanied by Kevin Eppers (Environmental Manager, Kensington Gold Mine) for the entire duration of the trip. The purpose of this inspection was a broad overview of the entire mine. It was Brad's first trip to the mine, and ADNR's first inspection since the snow had melted. Transportation to and from the mine was provided by a United States Forest Service (USFS) chartered Ward Air DeHavilland Beaver floatplane.

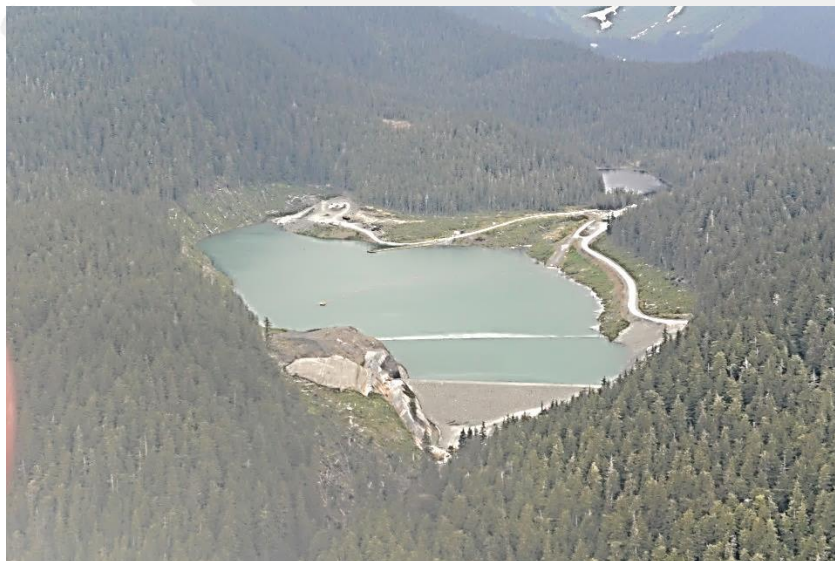
Figure 1 Aerial view of the Tailings Treatment Facility.

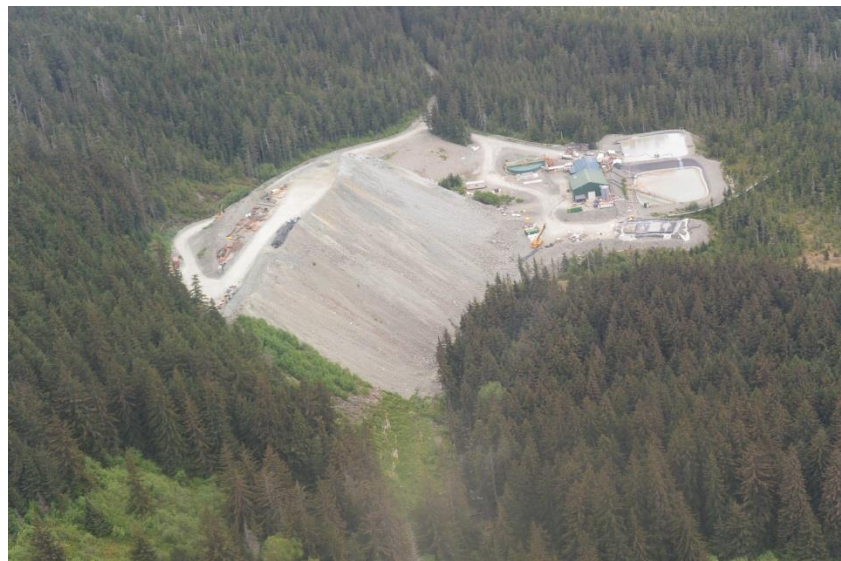
Figure 2 Aerial view of the Comet waste rock pile and water treatment plant.

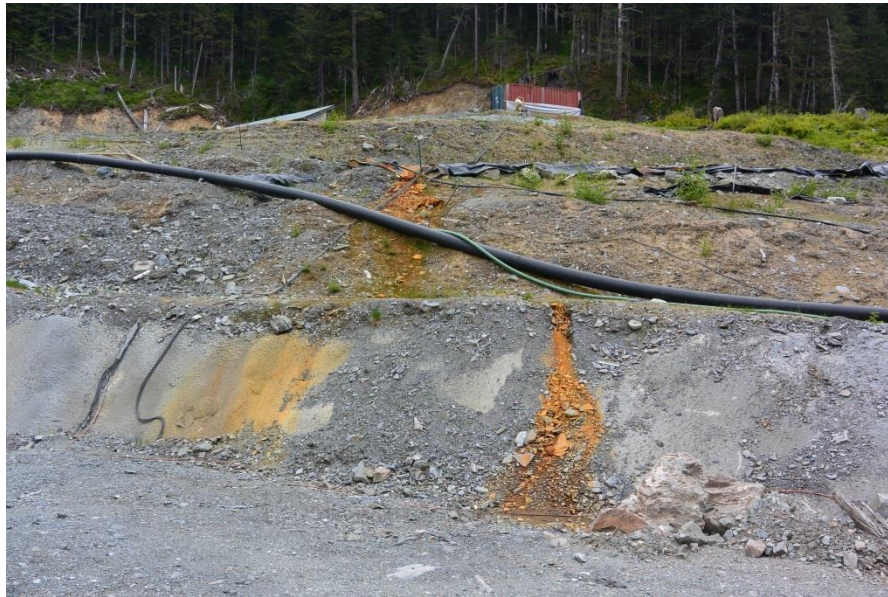
The access road to the Tailings Facility was in good condition and appeared to have survived well through the milder than normal Alaska winter. The team stopped below the TTF Dam and walked around the area on foot. The localized staining visible on the lower eastern embankment below the dam appears to be worsening with time (Figure 3).

The orange staining has been mentioned in previous inspection reports (August 8, 2013¹¹, October 29, 2013), and is likely being generated due to the graphitic phyllite that was buried below the east end of the dam. The Potentially Acid Generating (PAG) material was buried during the initial construction of the dam after being encountered during the excavation of the dam abutment. The buried material was surrounded by a diorite “shell” containing a high carbonate content. The diorite was intended to neutralize any acid produced by the buried

Figure 3 Orange staining below the Tailings Treatment Facility Dam.

graphitic phyllite, but the orange staining may indicate that some acid rock drainage is seeping from the pile. The buried graphitic phyllite will eventually be excavated and hauled underground when room becomes available.

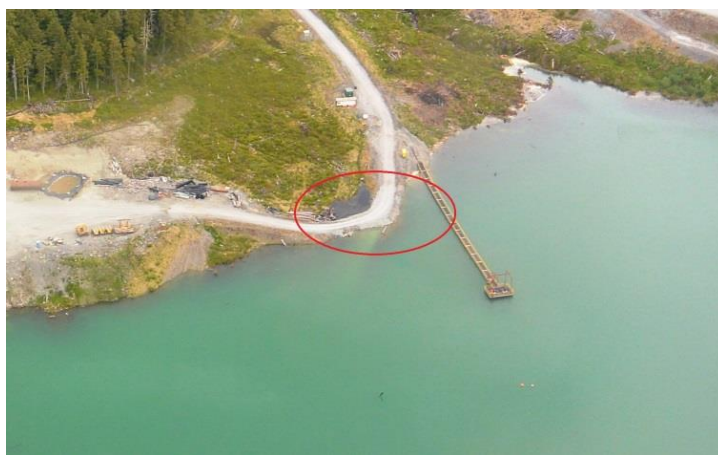
had been accidentally placed more than a year before. The access road to the barrel test area had been reconstructed due to rising water levels during the spring runoff. The new road follows the same alignment, but fill had been placed at the lowest elevation to ensure that the road was not inundated by the rising waters (Figure 4).

Figure 4 Filled road bed area.

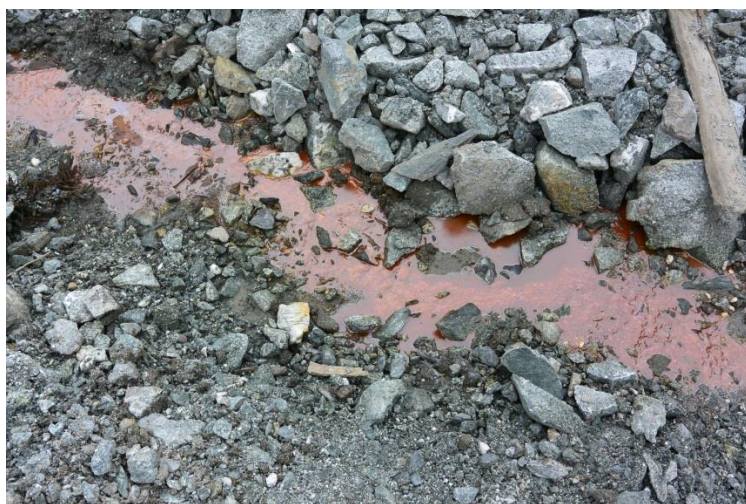
Figure 5 The discoloration in this seep appeared to be the result of organic decomposition and digestion by iron bacteria.

A closer look at the toe of the pile revealed that orange staining could be found in several areas. However, it is believed that much of the staining may not have been as a result of Acid Rock Drainage (ARD). Upon closer inspection, the far south seep revealed a floating scum and rainbow sheen indicative of iron bacteria (Figure 5). The majority of the discoloration is likely due to the natural function of anoxic iron bacteria breaking down organic material in the original topsoil stockpile that was placed in the area during the original construction of

the TTF dam. Field tests show a near neutral pH and low conductivity from the south seep. However, the middle seep continues to show that some parameters do not meet permit requirements², hence the small additional amount of excavated material.

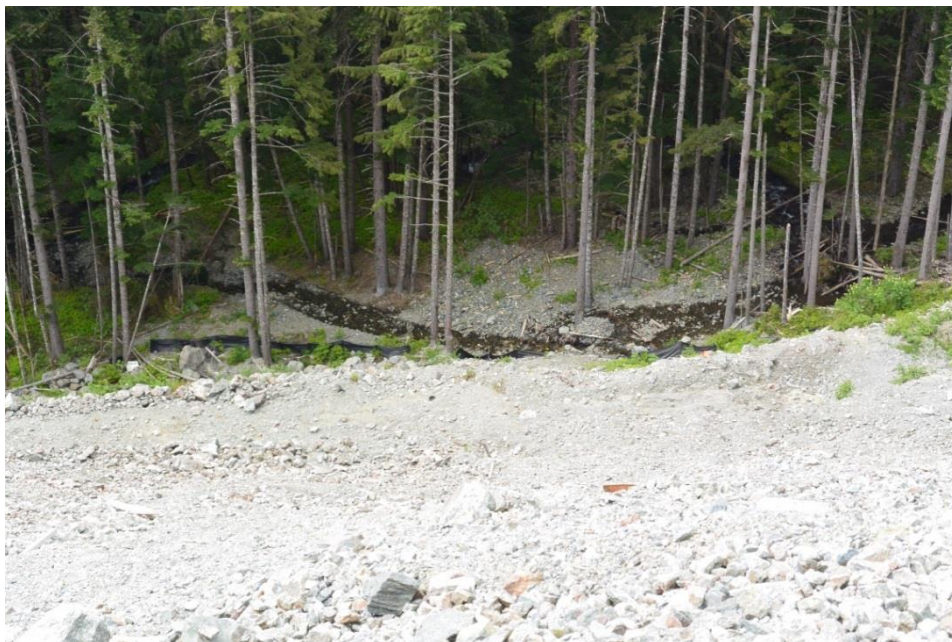
Figure 7 The silt fence running between the Comet Wasterock Pile and Ophir Creek was partially buried.

rolled into the now flowing Ophir Creek. However, the silt fence at the bottom of the pile, designed to reduce the sediment flowing into Ophir Creek was in disrepair (Figure 7). The top of the pile was being used to store mine equipment, and was clean and tidy.
